660 West Main Street Structural Condition Report

On Tuesday, January 29, 2013 I inspected the structure at 660 West Main Street, Rochester, NY. This report addresses the current structural status of the building. It also provides schematic level information for possible repair and rehabilitation methods. The architectural and/or historical significance of the facility to the community is not addressed. The presence of asbestos containing materials, lead materials and mold is also not covered in this report.

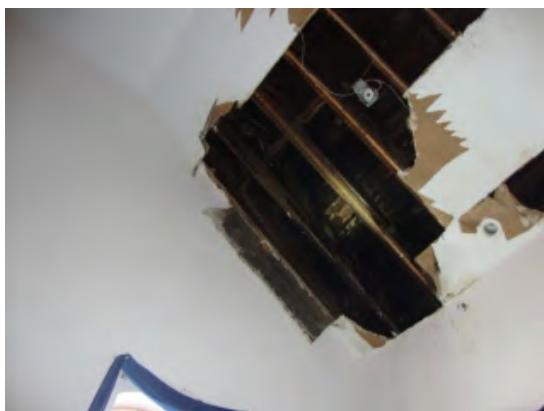
Image 09- SW Sanctuary Roof Leak

DEF-01: A new roof system is required for the entire original building. The main entry roof on the three story tower may be okay but would require a closer inspection to determine. With this roof replacement there will be localized areas that require new roof sheathing. The area noted under DEF-02 below and shown in Image 09 being the largest by far.

DEF-02: There is a large area of the roof that is compromised at the southwest corner of the sanctuary space (Image 09 and 10). At the time of inspection water was freely dripping down from above covering an approximate 20'x16' area. The roof sheathing, rafters, floor joists and subfloor within this area were noticeably saturated. The subfloor was warped or bowing due to the saturation. The roof sheathing and subfloor within this area would need to be replaced with new plywood. The rafters and floor joists may require new 2x sistered joists within these areas as well. That would need to be determined upon closer inspection.

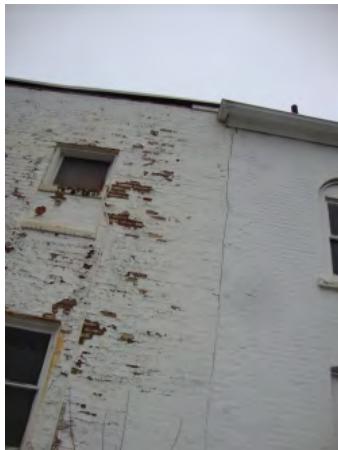
Image 11- East Entry Brick Joint

DEF-09: There is a noticeable opened joint where the addition brick meets the original building brick this joint could be a source for water infiltration (Image 11).

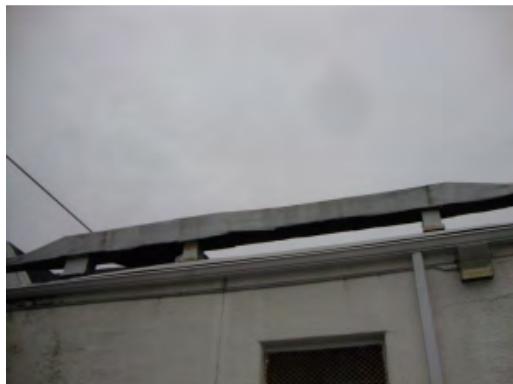
Image 13- Exterior Ductwork

DEF -11: There are significant leaks at ductwork penetrations coming down from above the roof (Image 13). A redesigned space should eliminate the exterior ductwork from above the roof.

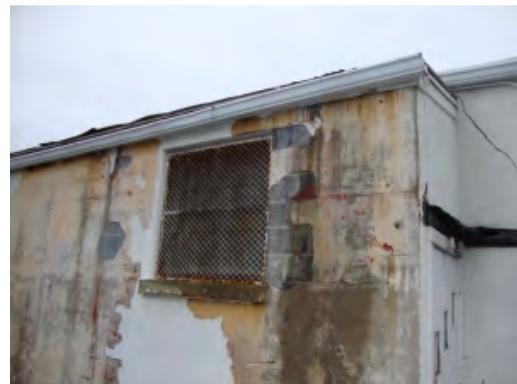
Image 14- Stucco damage

DEF-12: The roof pitches to all roof edges and surrounding gutters. This has allowed long term exposure of the exterior walls to large amounts of shedding water, the stucco finish in particular. The vast majority of the stucco finish is damaged beyond repair as well as a few of the protruding window sill ledges (Image 14). The roof system should be replaced with a new drainage concept that provides tapered insulation to one or more center roof drains. This would eliminate the gutters and the continued damage to the exterior walls. The exterior walls then require a new finish product applied to their exterior.

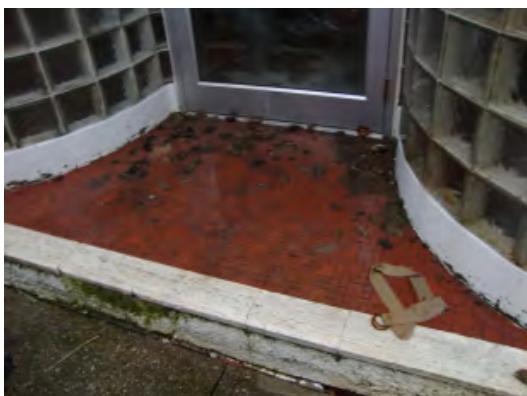
Image 15- Exterior Door Stoop

DEF-13: A portion of the landing at the cast-in-place stair on the east side of the addition protrudes to the exterior and creates the stoop at that side entrance (Image 15). This stoop appears to have been heavily salted at times. The reinforcing in the slab has begun to corrode (Image 16). The damage is visible from the underside crawl space. This portion of the slab should be patched or completely replaced. A new entry design should eliminate the recess at this entrance so that the slab is no longer exposed to the exterior.

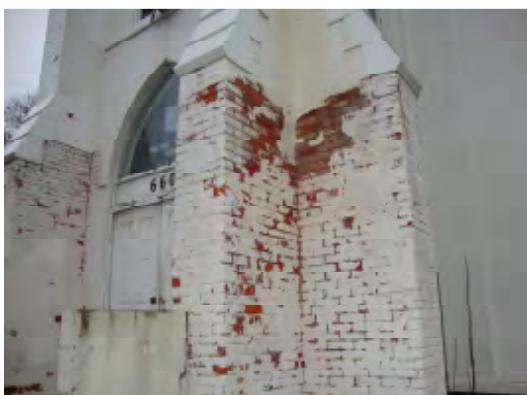
Image 17- Peeling Paint

The original structure and the East Entry all have brick facades that have received a waterproofing paint application. As previously discussed there are many areas where the paint is peeling. In those areas it is clear that the brick mortar is deteriorated. The main cause of this deterioration is more than likely due to the paint coating itself (Image 17 and 18).

I inspected a few areas where the paint is peeling. At these locations the mortar is fairly loose and can be ground out with little effort. The brick at these locations appears to be in relatively good condition. Where the paint is peeling it comes off with little effort and peels off in large membrane like sections. Where the paint is not actively peeling it appears to be well adhered.

I recommend complete removal of the painted application. Once removed a vast majority of the brick will require repointing. Repointing involves the removal of the existing mortar by hand tools or small mechanical tools in small area increments so as not to compromise large areas of the veneer. Once the mortar is removed new mortar is "tucked" back into the brick joint. See section 7 for a brief discussion on proper mortar repair on historical brick structures.
